**Phase IV RFI Work Plan
DuPont Belle Plant
Belle, West Virginia**

Phase IV RFI Work Plan DuPont Belle Plant Belle, West Virginia

Date: October 2012

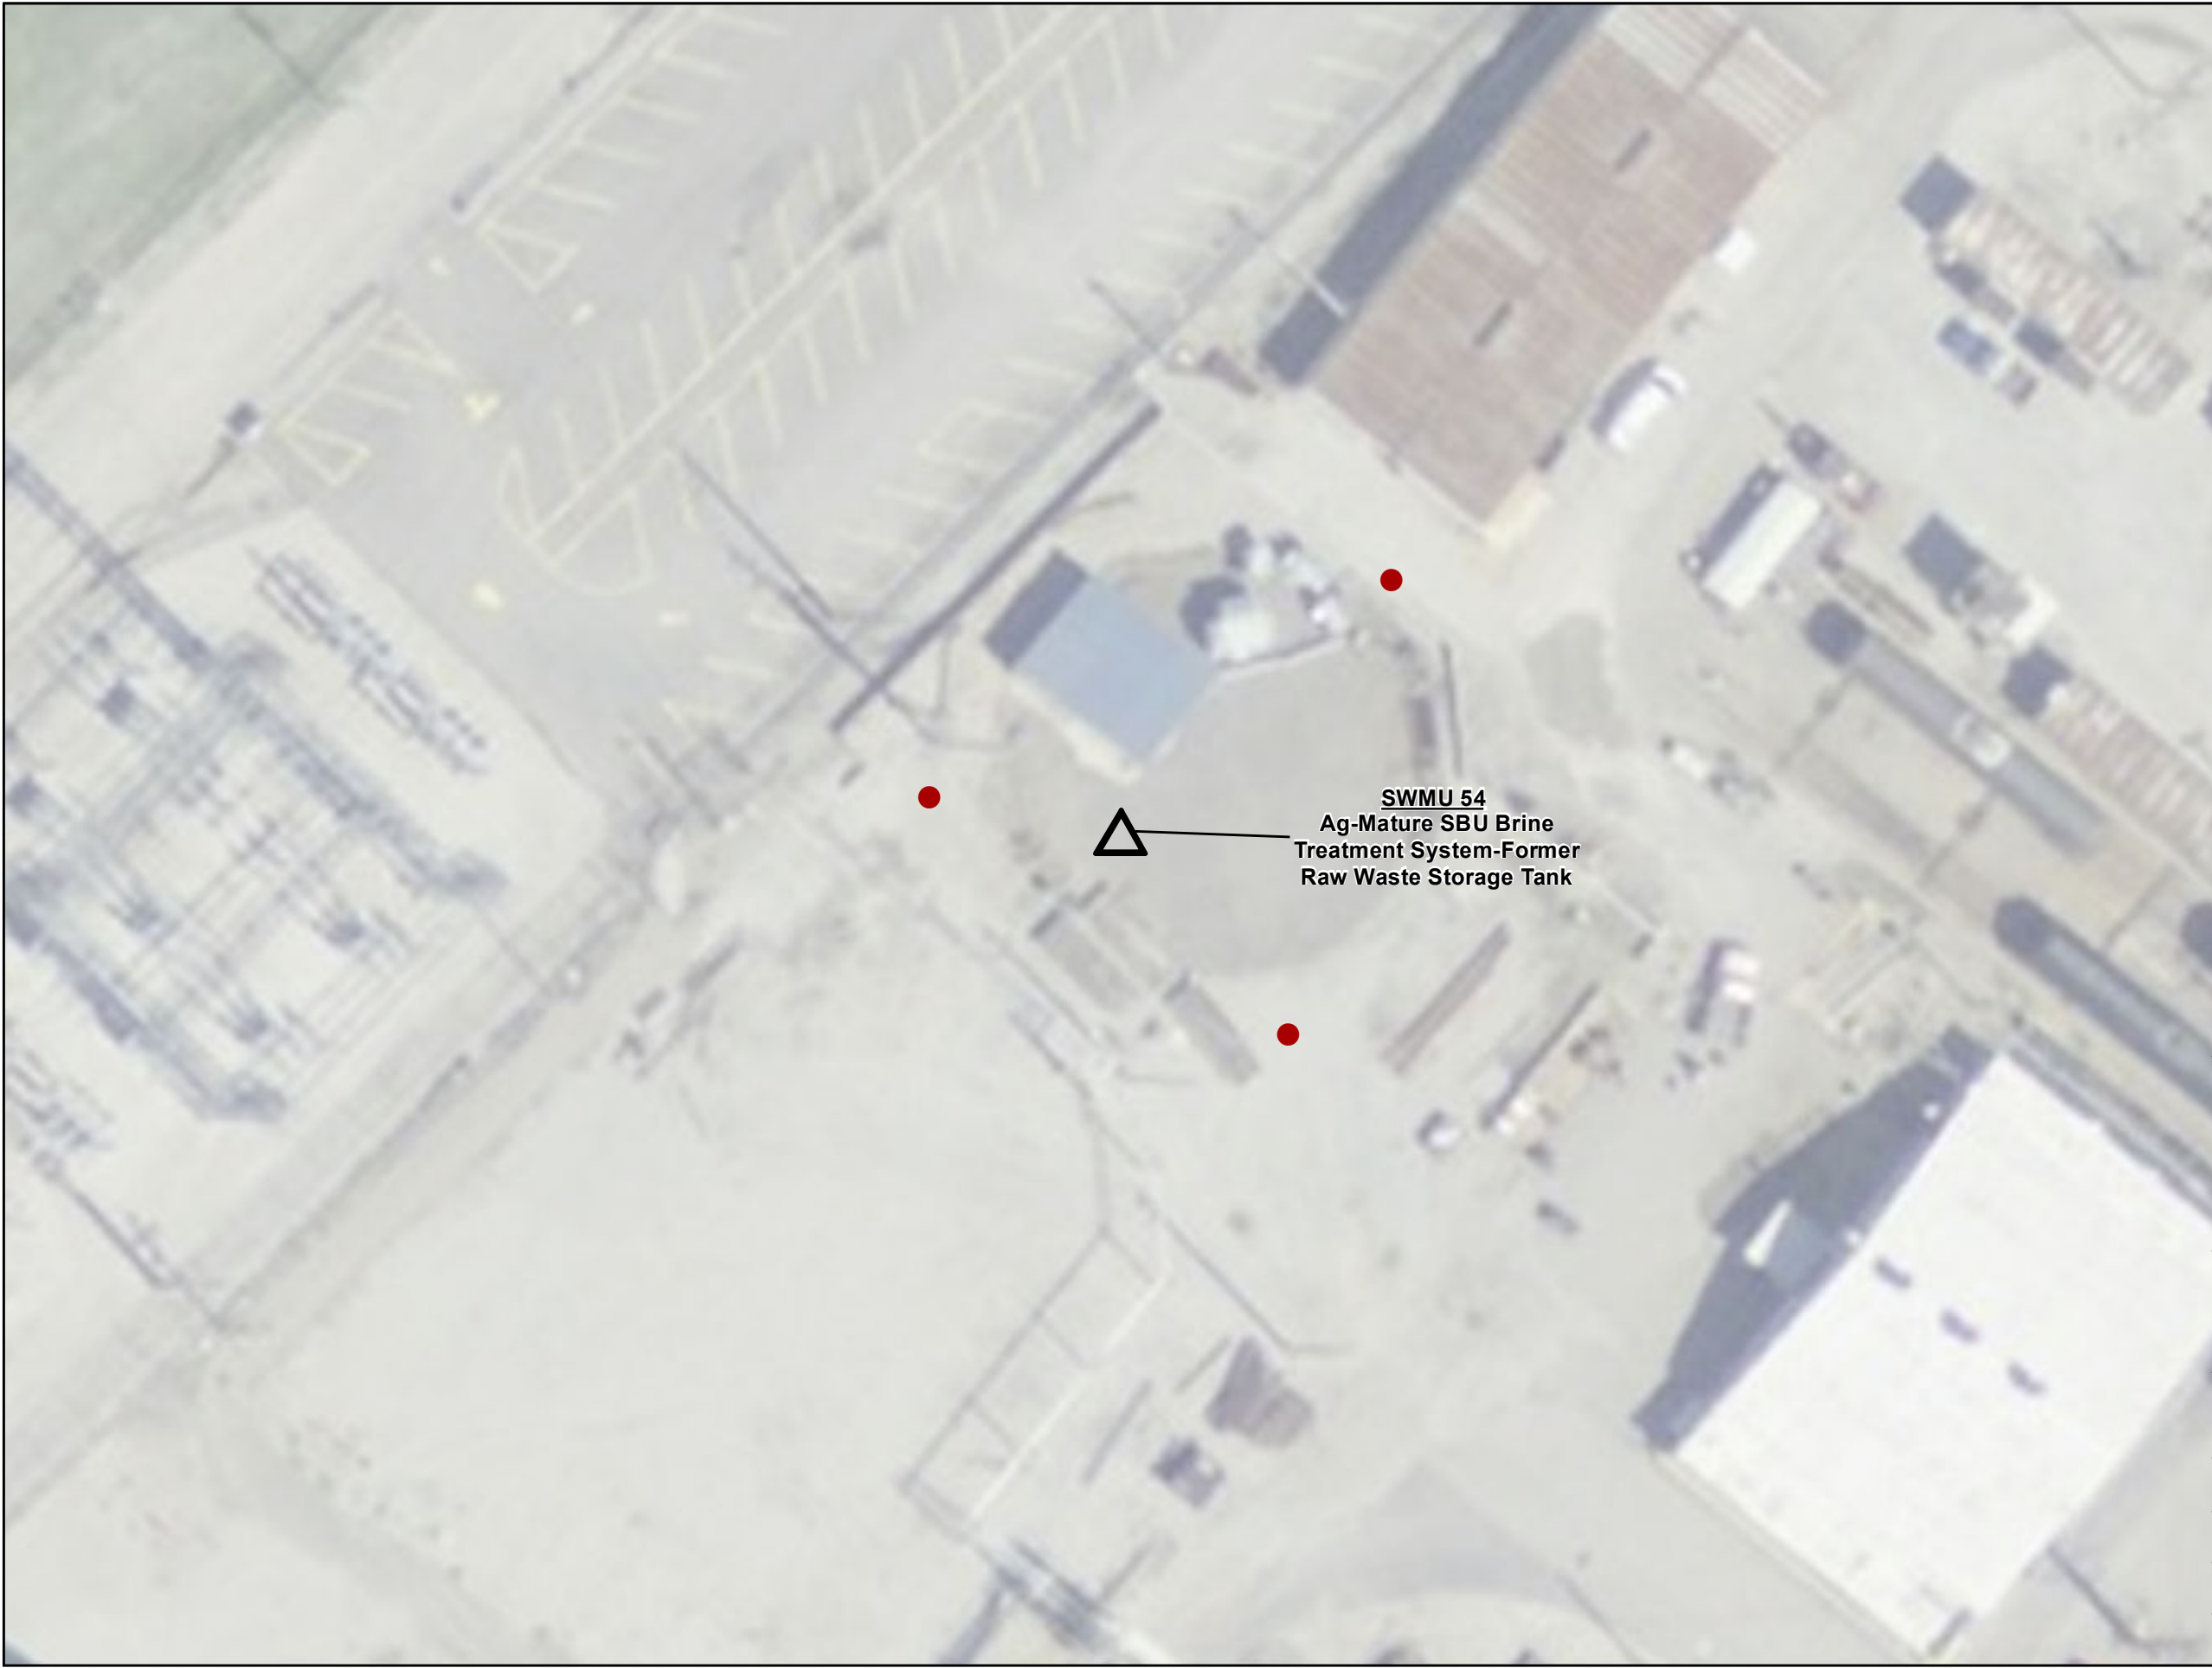
| DRAWN BY: CAA | FIGURE NUMBER: 1 |

- Proposed Soil Boring
- SWMU

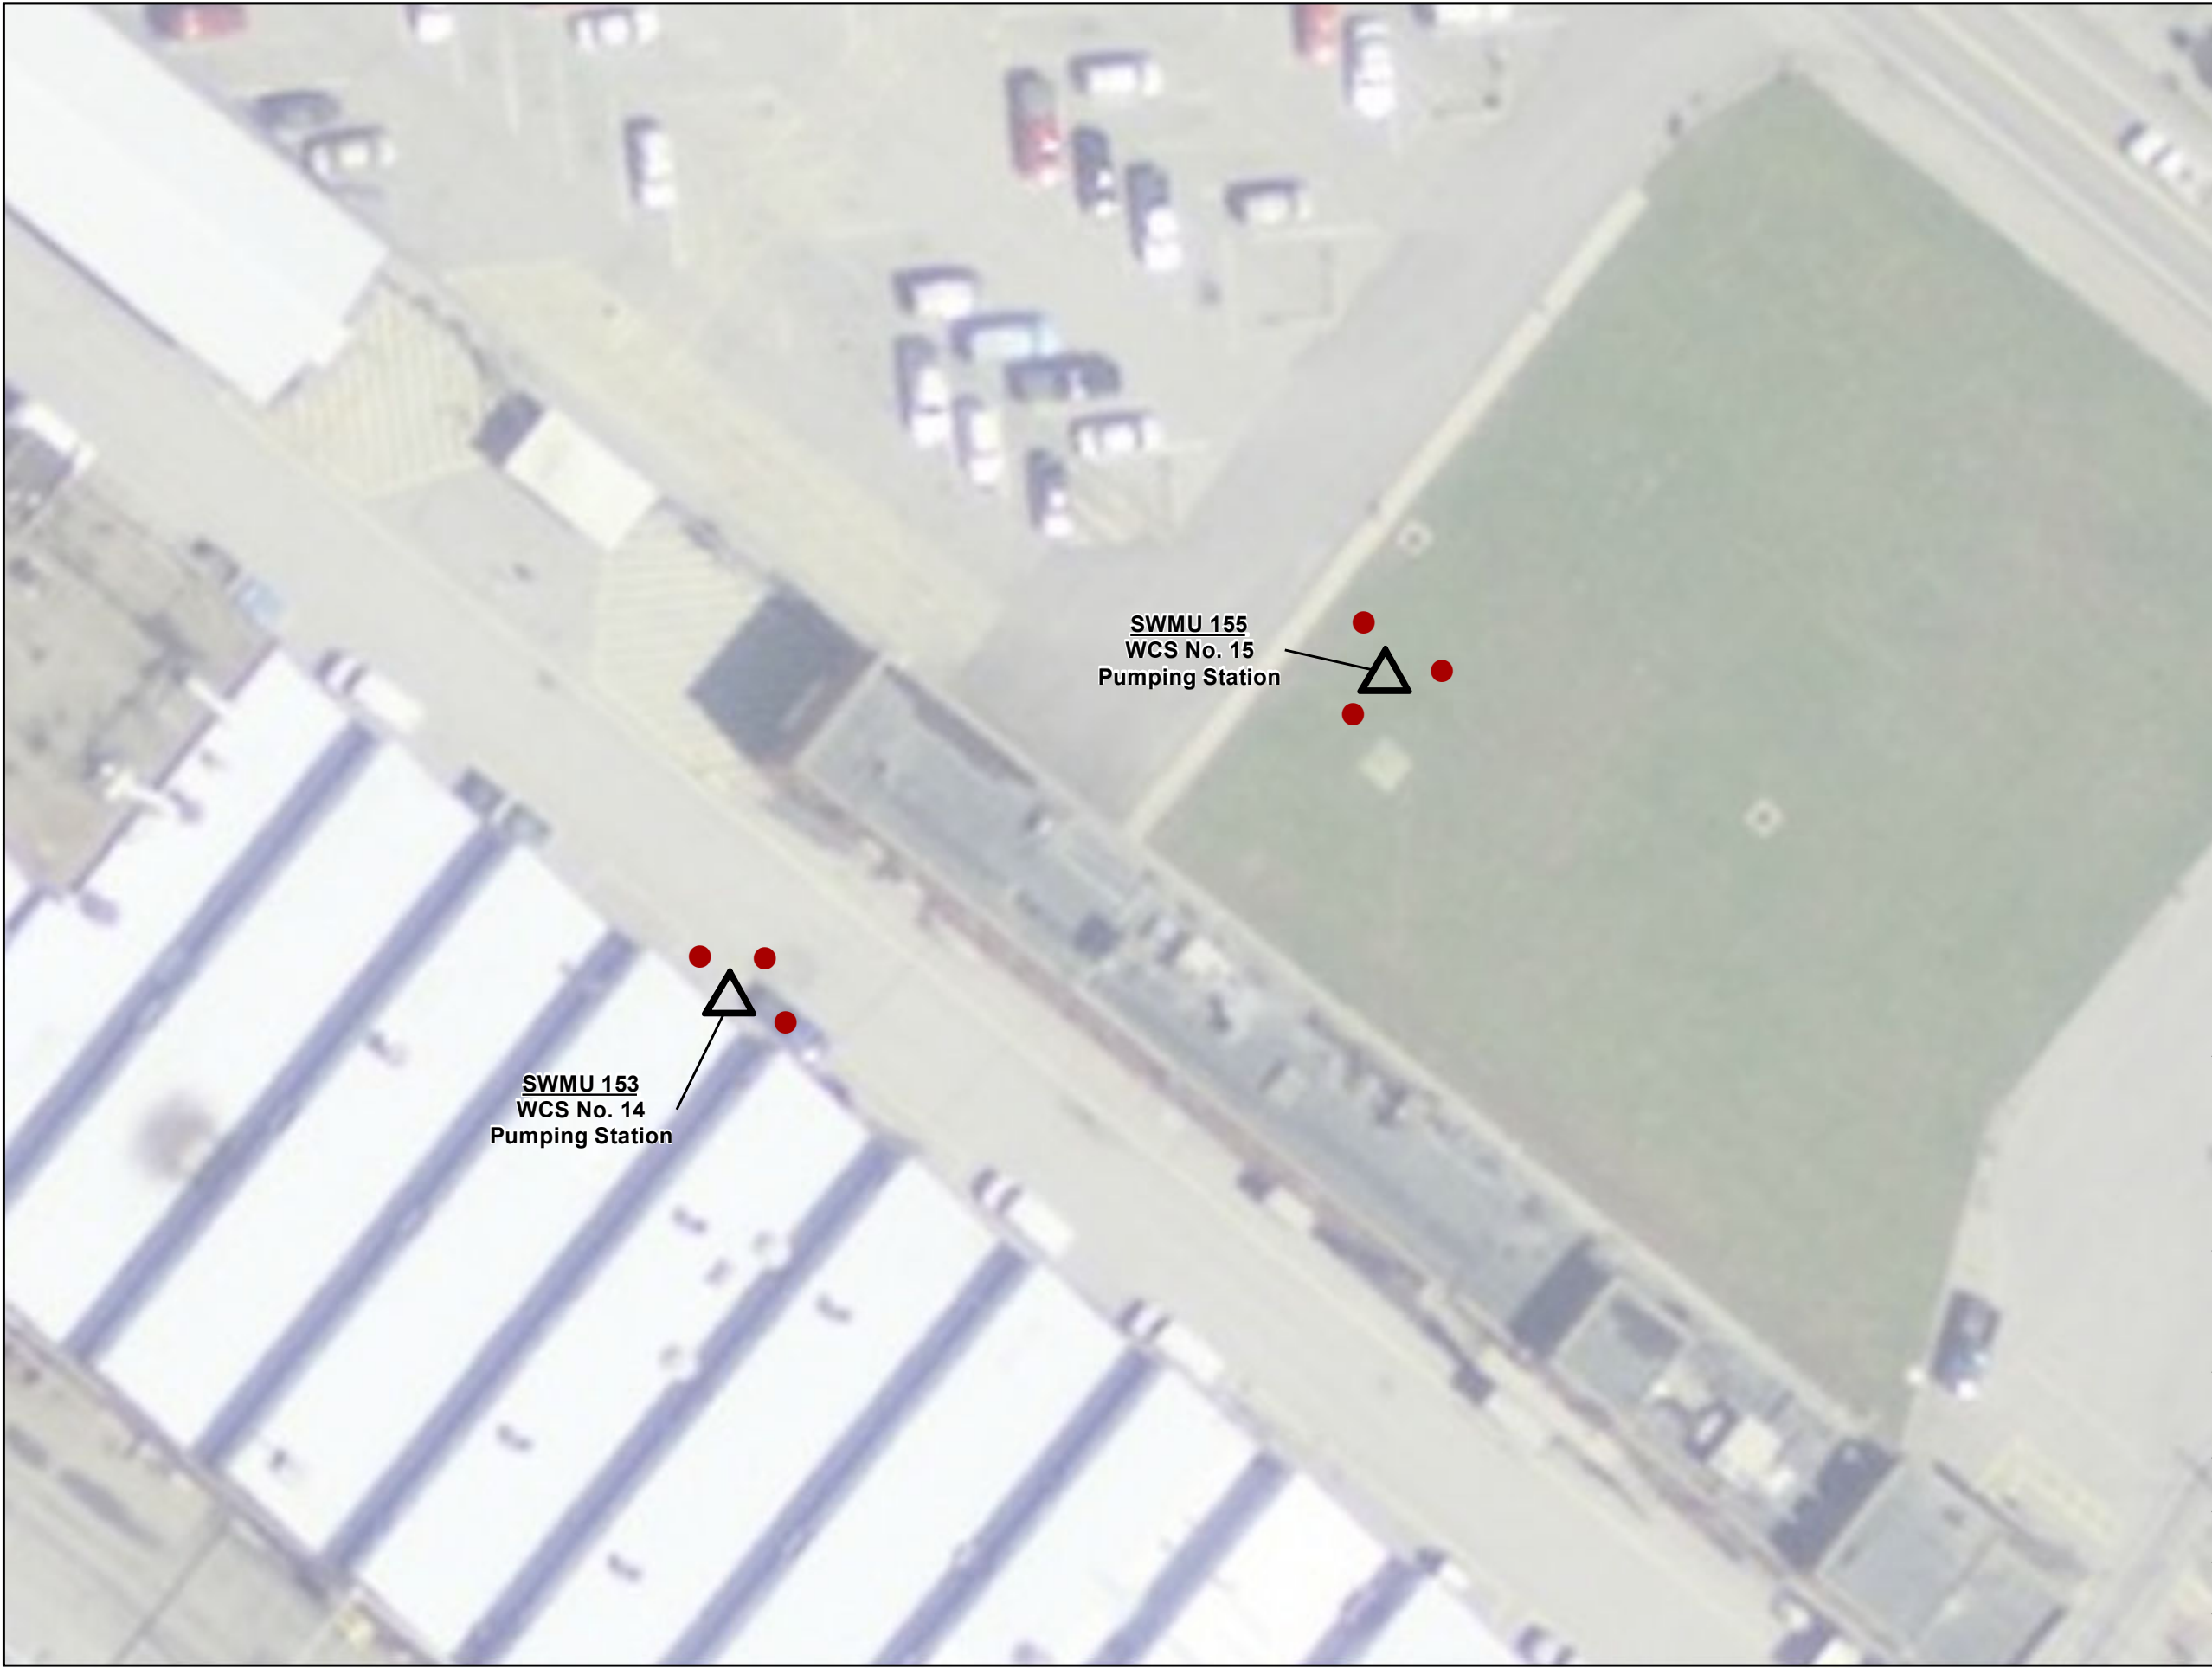
| DRAWN BY: CAA | FIGURE NUMBER: 4 |

Proposed Soil Boring

| SWMU/ AOC Number | SWMU/AOC Name | SWMU/AOC Description [from Current Conditions Report (1999)] | 2012 SWMU/AOC Description | Investigation Rational Based on Decision Tree Evaluation | Proposed Investigation |
|---|--|--|--|--|---|
| 153 | WCS No. 14 Pumping Station | These units (SWMUs 145 to 161) consist of the Facility sewer lines, a series of pumping stations, collection flumes, and ancillary pumps. The purpose of these units is to collect both sanitary and process waste waters and convey the wastes to the WWTP. The system is all gravity flow. Small infrequent overflows have occurred from the pumping stations due to equipment failure. Lines are replaced on an as-needed basis as lines fail. Releases have occurred from these units. | In use. | <ul style="list-style-type: none"> Known releases No relevant data | 3 borings VOCs SVOCs Metals See Figure 4 |

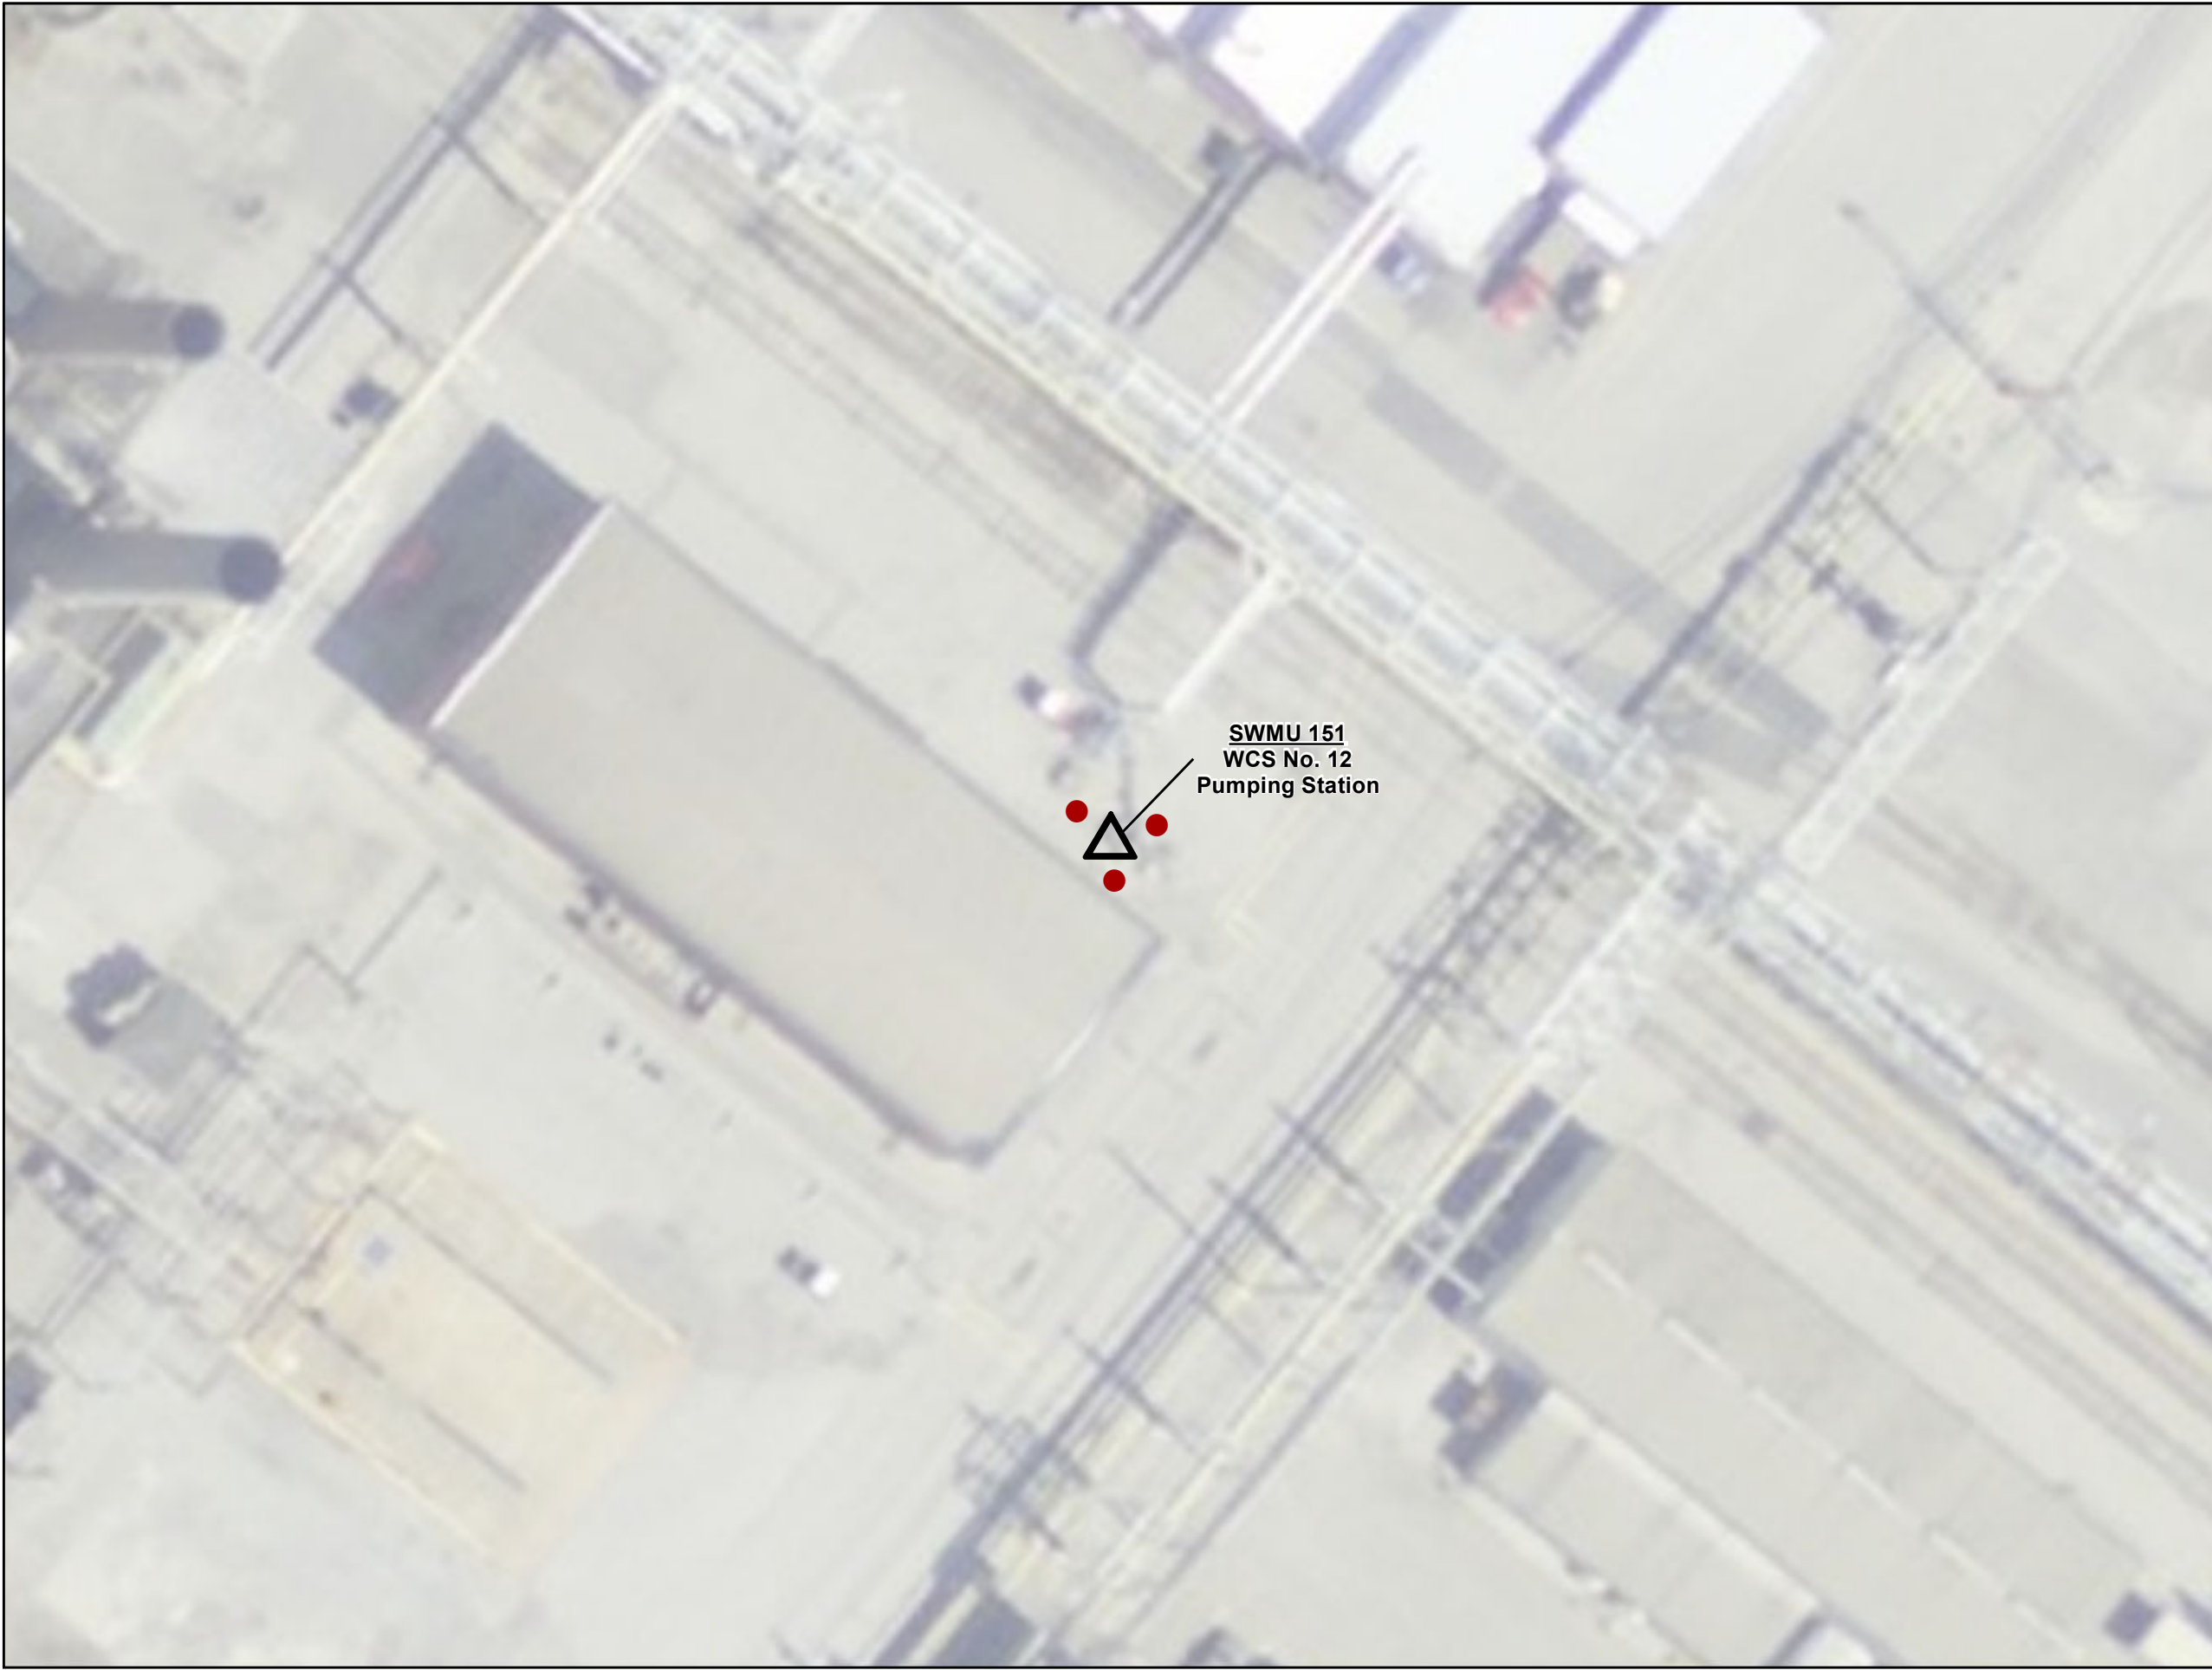
| DRAWN BY: CAA | FIGURE NUMBER: 5 |

Proposed Soil Boring

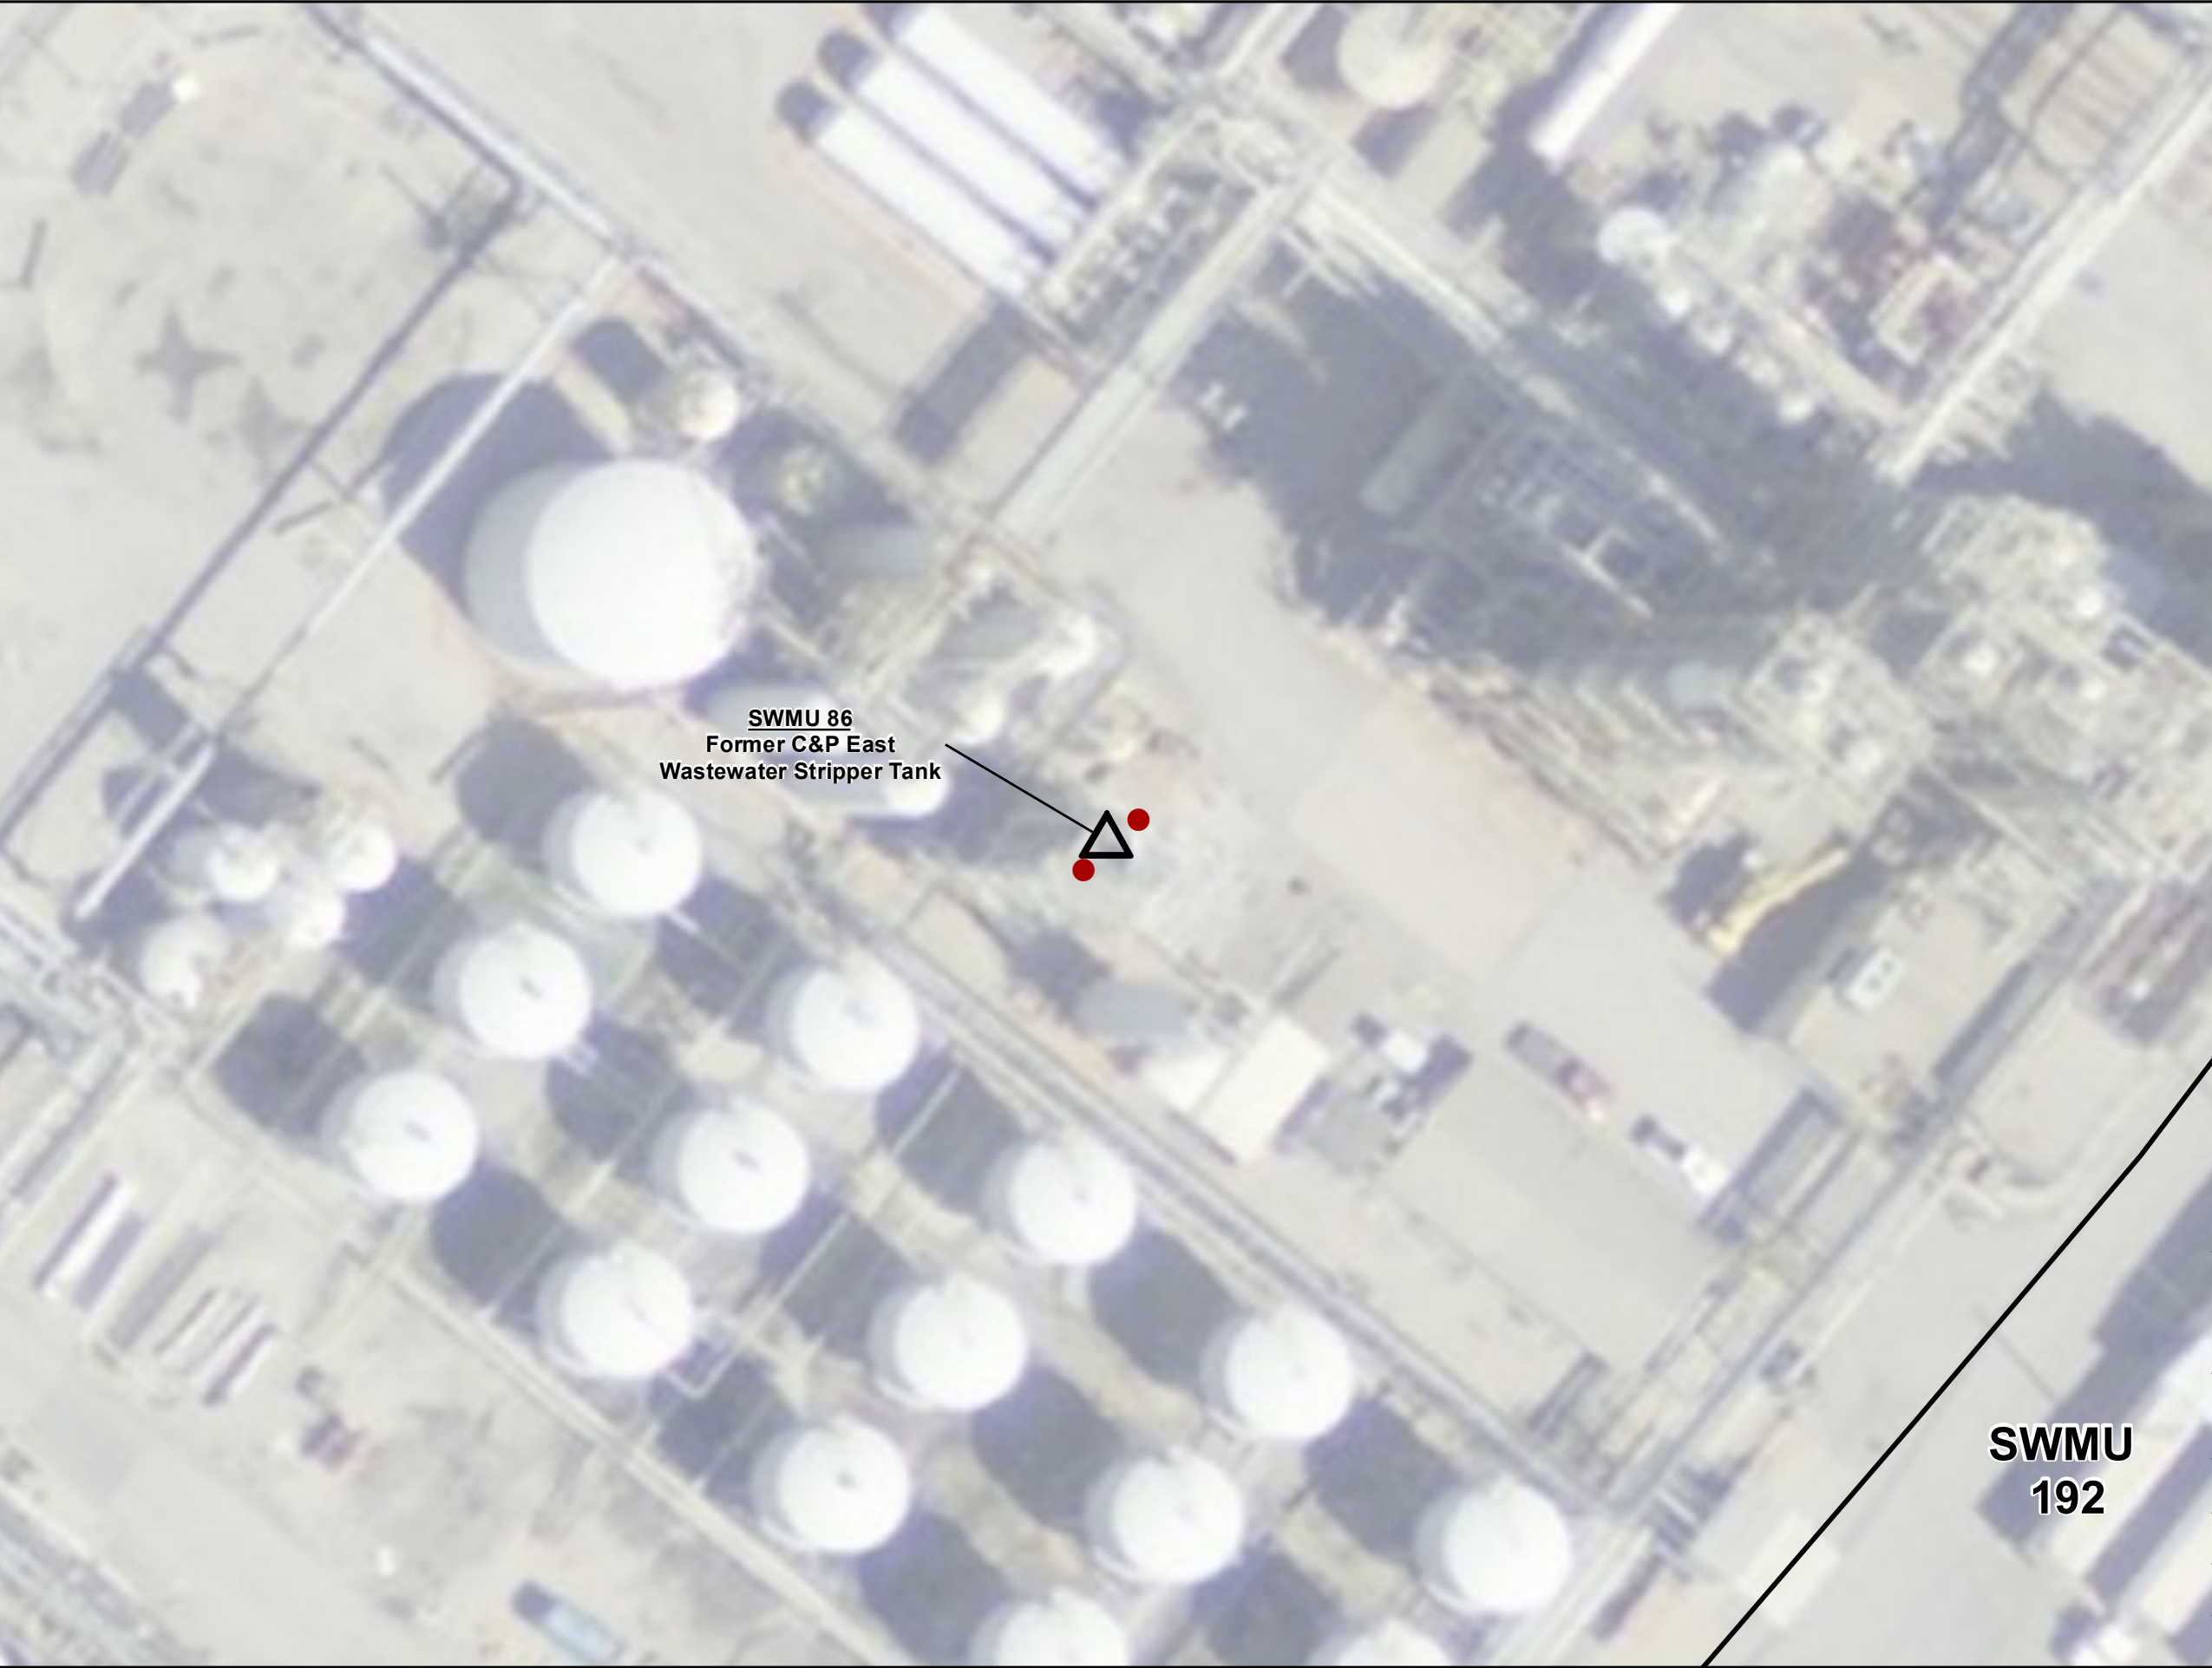
| DRAWN BY: CAA | FIGURE NUMBER: 8 |

| SWMU/ AOC Number | SWMU/AOC Name | SWMU/AOC Description [from Current Conditions Report (1999)] | 2012 SWMU/AOC Description | Investigation Rational Based on Decision Tree Evaluation | Proposed Investigation |
|---|---|---|--|--|--|
| 73 74 75 76 | Former PACM Heel Tank No. 1 Heel Tank No. 2 Waste Tank No. 1 Waste Tank No. 2 | There are four identical carbon steel, closed-top, 17,000-gallon units (SWMUs 73-76) which are used to accumulate waste from the PACM process. These units are each 9 ft. in diameter and 36 ft. tall. The tanks are mounted on steel legs on a small concrete foundation surrounded by gravel. The units ceased operation in 1988 and were cleaned out. The units were dismantled in 1998. | Tanks were removed and the area is now being used for scaffold equipment storage. Area is covered with gravel lots and asphalt pads. | <ul style="list-style-type: none"> One release occurred No secondary containment - concrete pad sloped towards trench on eastern side, but could drain to east into gravel No relevant data | <p>4 borings</p> <p>VOCs SVOCs Metals</p> <p>See Figure 8</p> |

SWMU 86
Former C&P East
Wastewater Stripper Tank

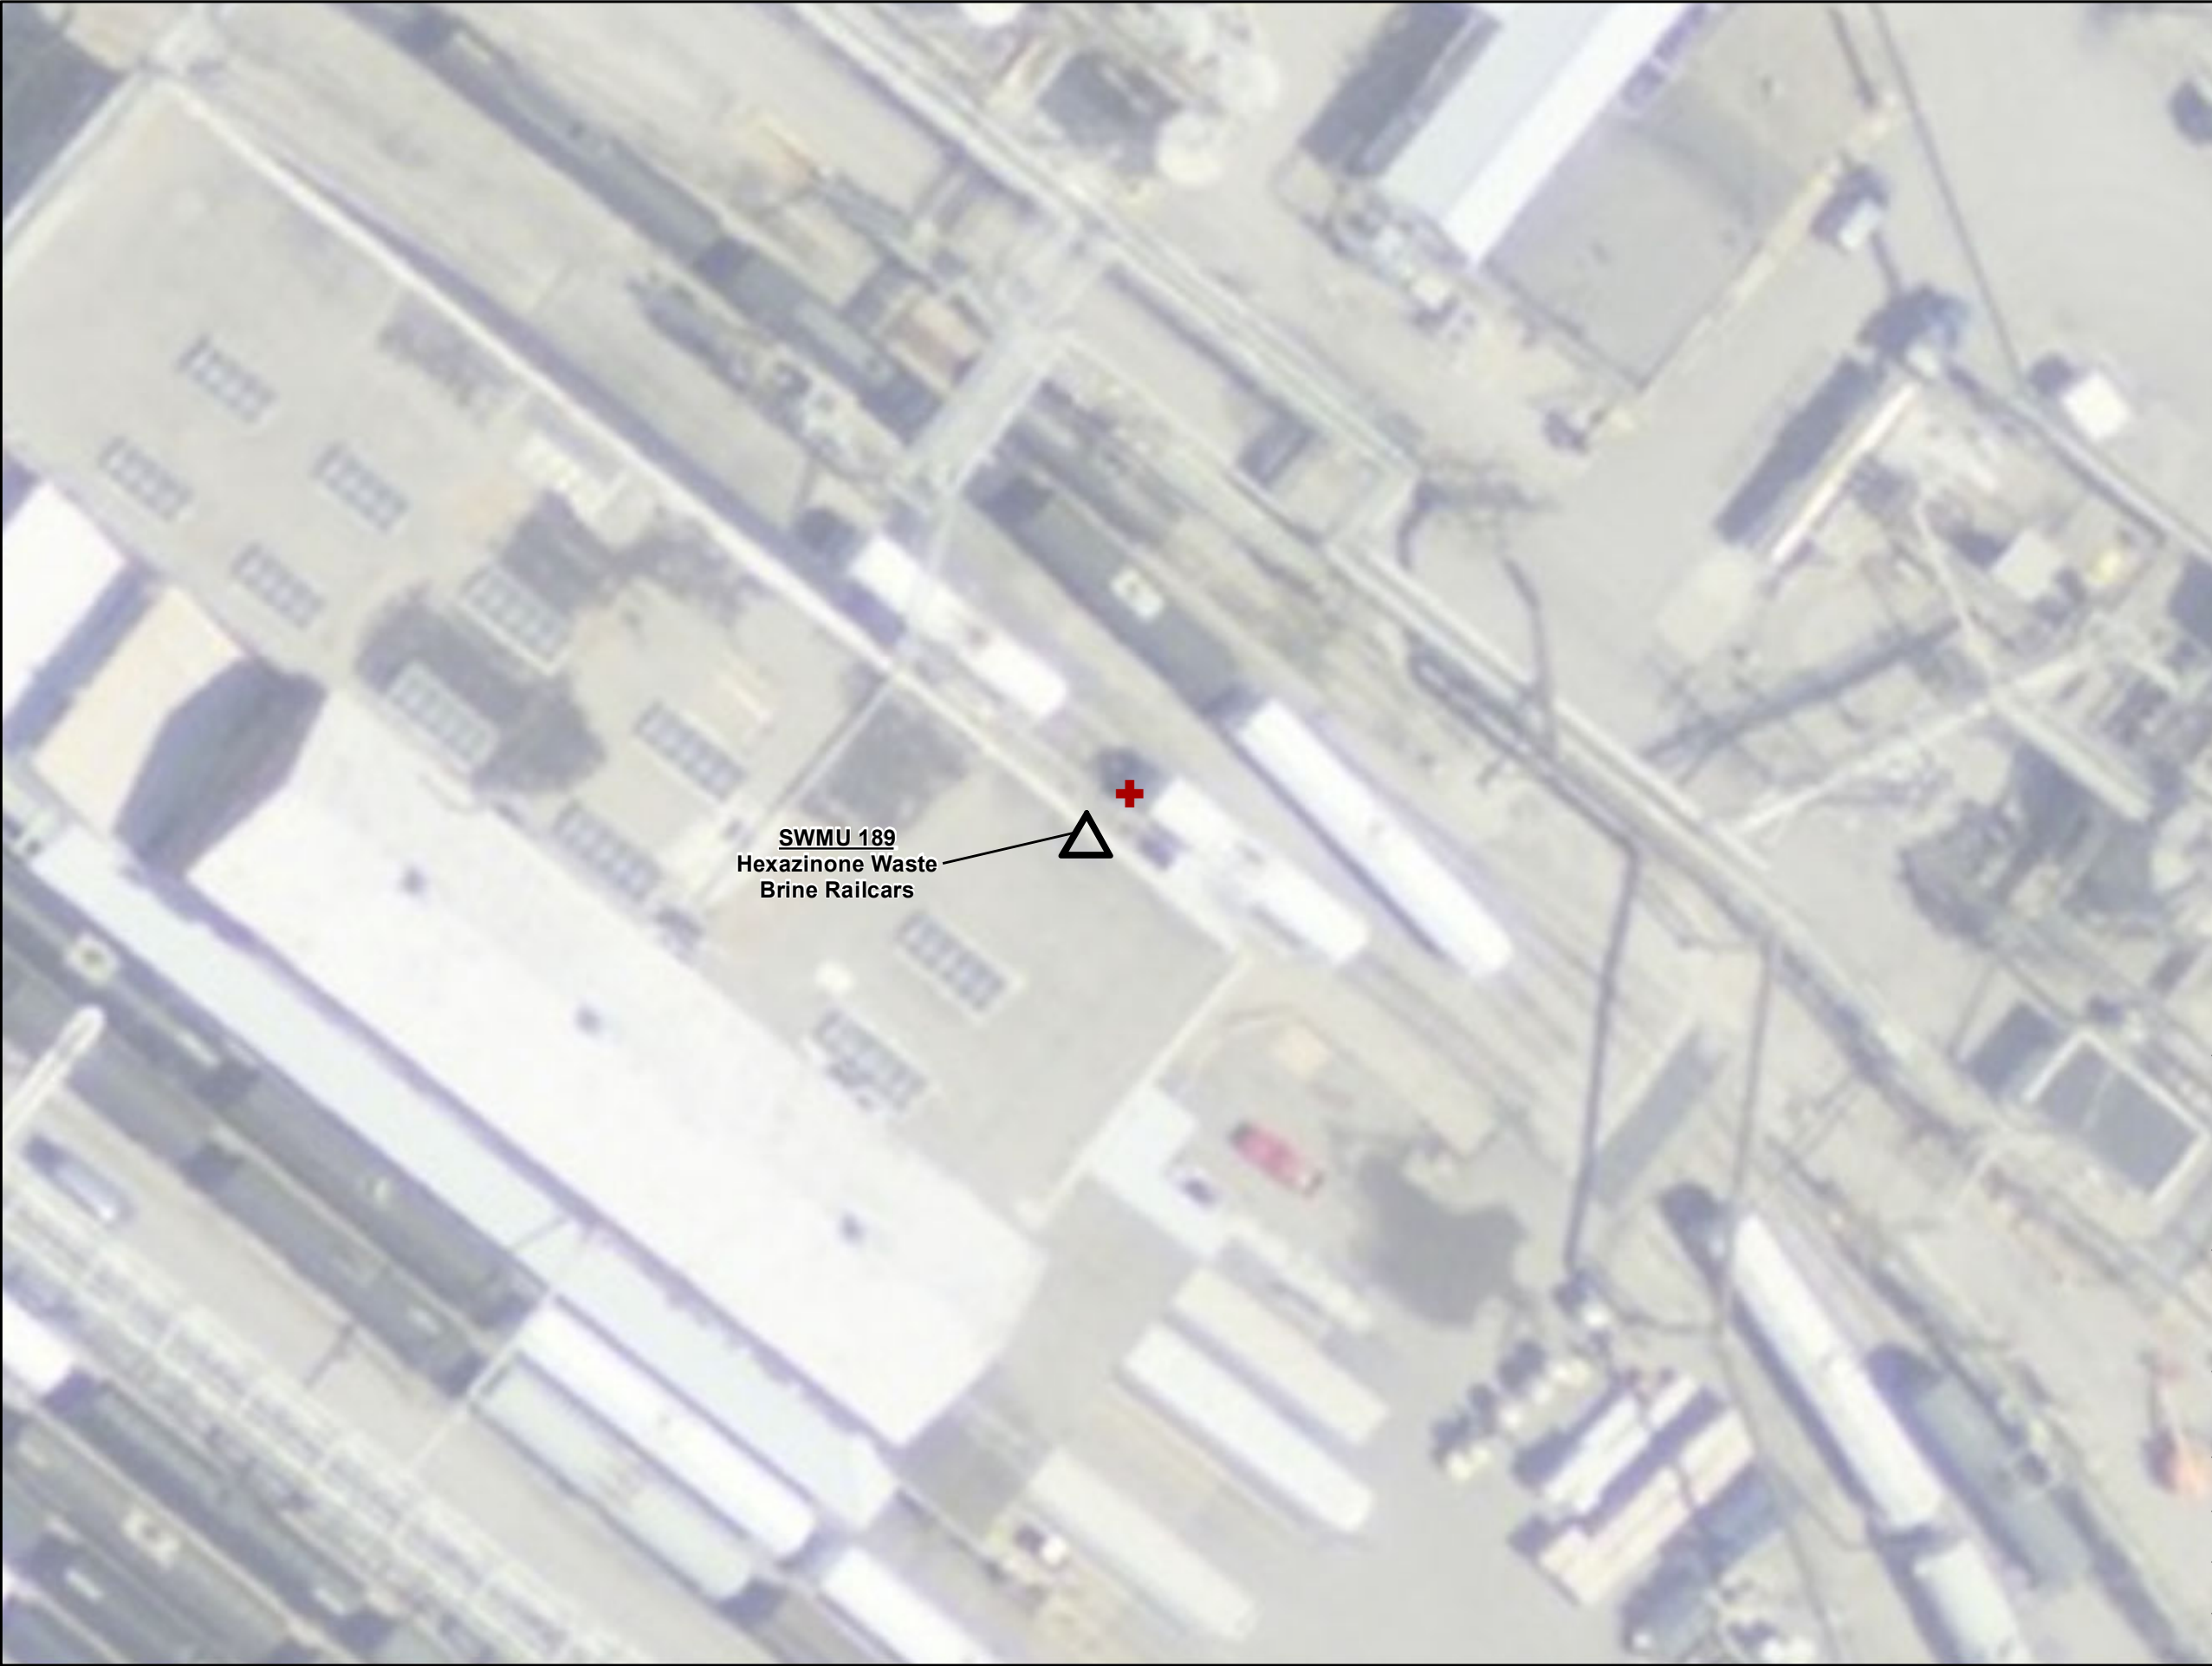
| DRAWN BY: CAA | FIGURE NUMBER: 14 |

| SWMU/ AOC Number | SWMU/AOC Name | SWMU/AOC Description [from Current Conditions Report (1999)] | 2012 SWMU/AOC Description | Investigation Rational Based on Decision Tree Evaluation | Proposed Investigation |
|---|---|--|--|---|---|
| AOC F | AOC F Formaldehyde Spill | On August 8, 1983, approximately 4,000-lb. of a 56% formaldehyde solution was discharged to Simmons Creek. The spill was caused by the failure of a process pump. | Storm sewer discharge point located. | <ul style="list-style-type: none"> This is an isolated spill of 56% formaldehyde solution due to an overflow in the pump containment system. Spill material entered a storm sewer which discharged to Simmons Creek. Sediments near the discharge point of the storm sewer into Simmons Creek will be sampled for evidence of the spill. | 3 surface sediment samples Formaldehyde See Figure 14 |

SWMU 189
Hexazinone Waste
Brine Railcars
